July 1982  
Final Report

DOT HS-806-323

## Improved Performance of Production Belt System Assembly for the Plymouth Horizon and Plymouth Reliant

Robert A. Galganski

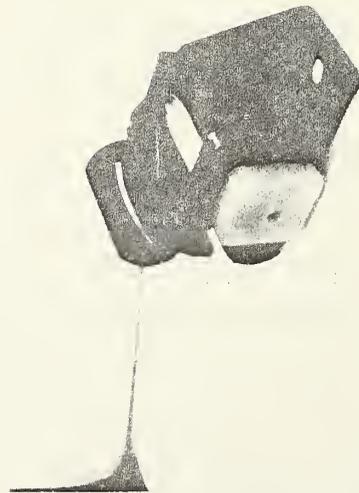
Figure 1 TAKATA KOJYO WEBBING CLAMP

MODIFIED VERSION USED IN PLYMOUTH RELIANT

The Reliant's production unibelt restraint system was modified by (1) the installation of a Takata Kojyo webbing clamp and conventional belt guide loop near the B-pillar; (2) removal of the standard-equipment, B-pillar-mounted D-ring; and (3) substitution of 8%-elongation Takata Kojyo webbing for the thinner, 7%-elongation production Reliant webbing. Photographs of the production and Reliant-adapted versions of the Takata Kojyo webbing clamp are presented in Figure 1.

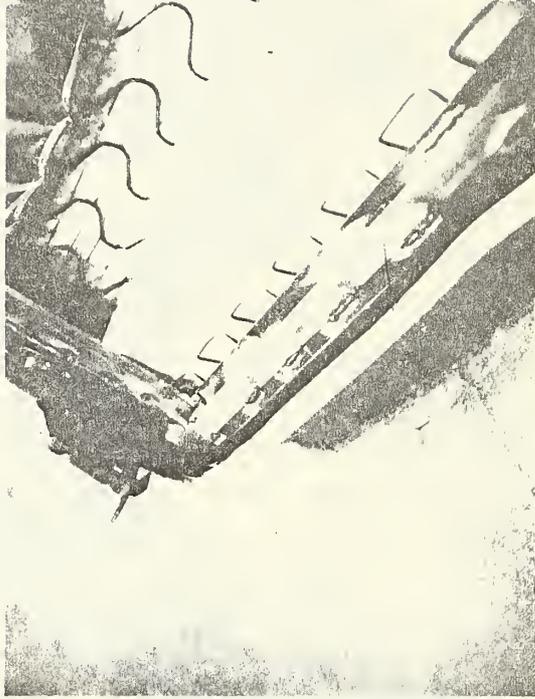
(b) SEAT CUSHION FRAME REINFORCEMENT

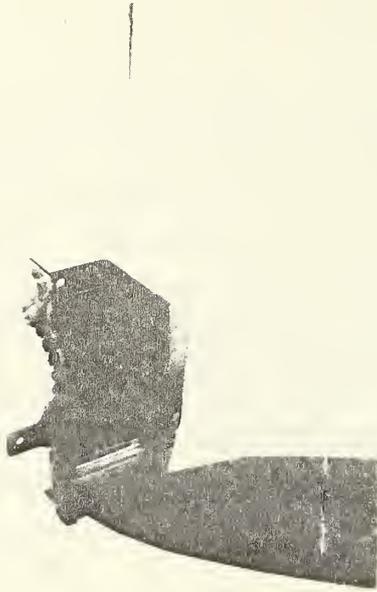
(a) PRODUCTION VERSION

Both Horizon production front seat belt restraint systems were replaced by a Takata Kojyo combination retractor/webbing clamp assembly, including 8%-elongation Takata Kojyo webbing. This device, shown in Figure 7a, is a variation of a production version used in the 1982 Honda Accord (4-door model). As such, it features the same, proven retractor lock-up/belt gripping mechanism. Only the inclination ( $26^\circ$  relative to the horizontal instead of a vertical orientation) is different. Thus with the Takata Kojyo unit mounted near the Horizon's zero-inclination (horizontal) side roof rail, the retractor was effectively locked up prior to the test. While this pre-locked condition certainly provided an advantage for the Horizon occupants during collision ride down, it is highly probable that essentially similar belt spool-off would have occurred if a hypothetical production Takata Kojyo unit designed for horizontal roof rail mounting were employed in this test.\*

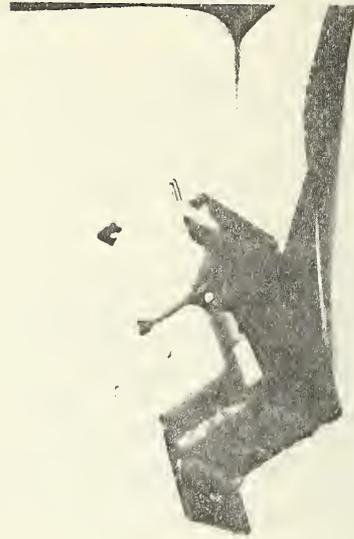
Figure 7 TAKATA KOJYO RETRACTOR/WEBBING CLAMP ASSEMBLY

(b) MODIFIED VERSION

The Takata Kojyo unit was adapted for bolt mounting to the roof rail as shown in Figure 7b. Passenger-side views of both the production and substitute

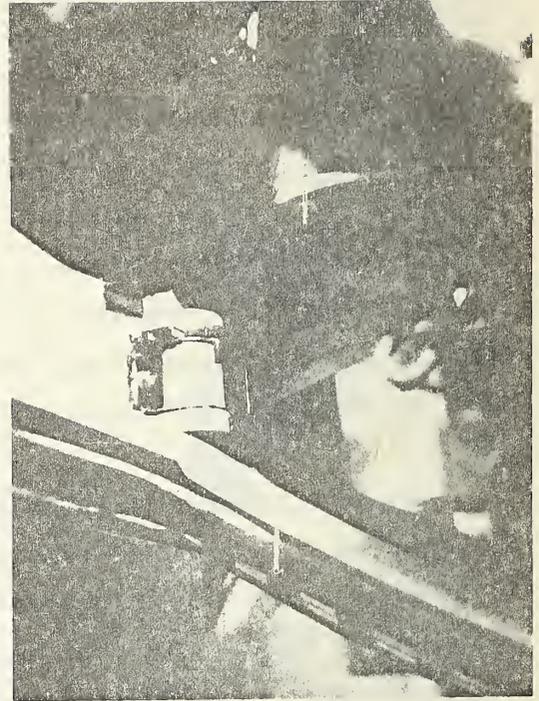
Figure 8 PLYMOUTH HORIZON RETRACTOR AT ROOF RAIL MOUNTING LOCATION

(b) TAKATA KOJYO SYSTEM USED IN CRASH TEST

retractor units at the common side roof rail mounting location are depicted in Figure 8. Figure 9 displays pre-test photographs of the Takata Kojyo restraint system belt configuration in place around the driver and passenger occupants.

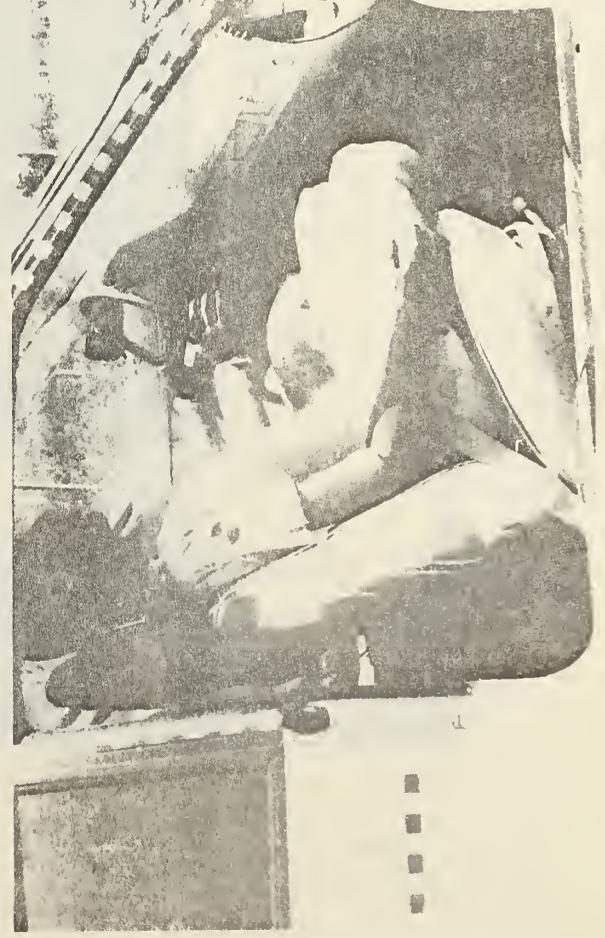
Figure 9 PLYMOUTH HORIZON TEST VEHICLE: TAKATA KOJOYO RESTRAINT SYSTEM BELT CONFIGURATION

PASSENGER

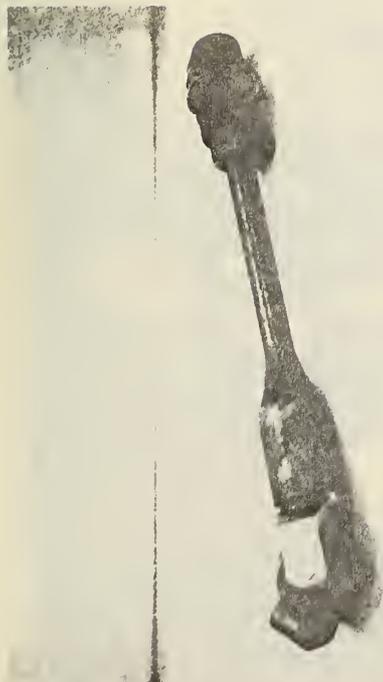
(a) PRODUCTION VERSION

shafts are presented in Figures 12a and 12b, respectively, while Figures 13a and 13b show these two assemblies in place in the vehicle.

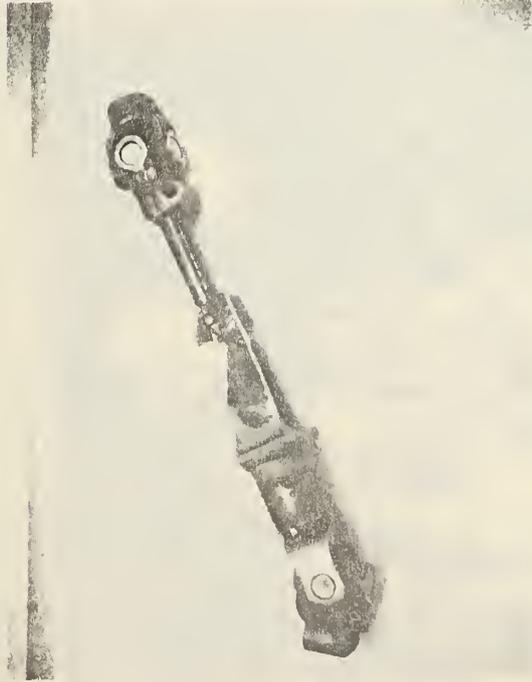
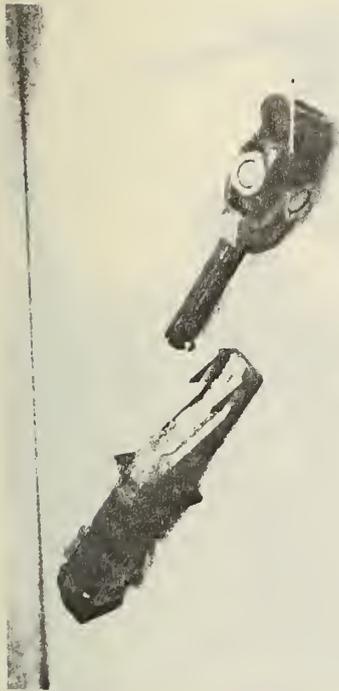
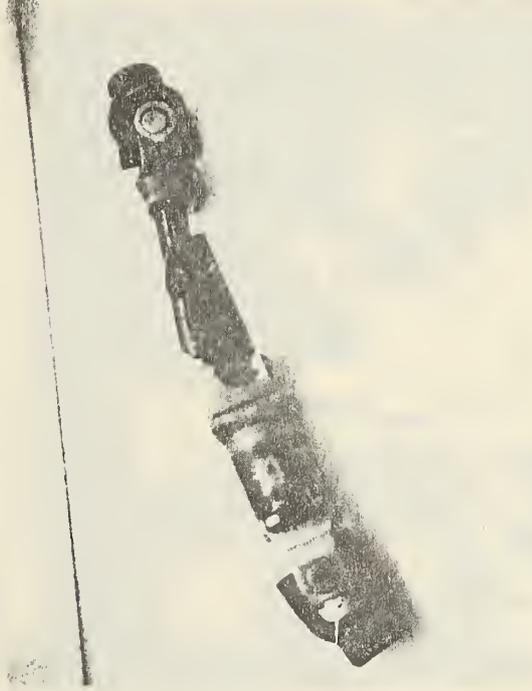
Figure 12 PLYMOUTH HORIZON LOWER STEERING SHAFT ASSEMBLY

(c) MODIFIED VERSION: COUPLED CONDITION

(b) MODIFIED VERSION

(d) MODIFIED VERSION: SEPARATION CONDITION
